Site & Visit Details	
Site Name	Four Seasons Shopping Centre
Site Contact	Shopping Centre Operations Manager
Client Order Number	BHM991299
Kendra Job Number	103M5163
Job Information	PPM Visit
Engineers Name	Richard Dodds
Date of Visit	03-07-2019

## Engineer's Report

### Technical Report

Attended site to carry out PPM visit on the existing Trend IQ3 system located throughout the shopping centre, the AHU controllers are contained within the AHU's located on the individual roofs.

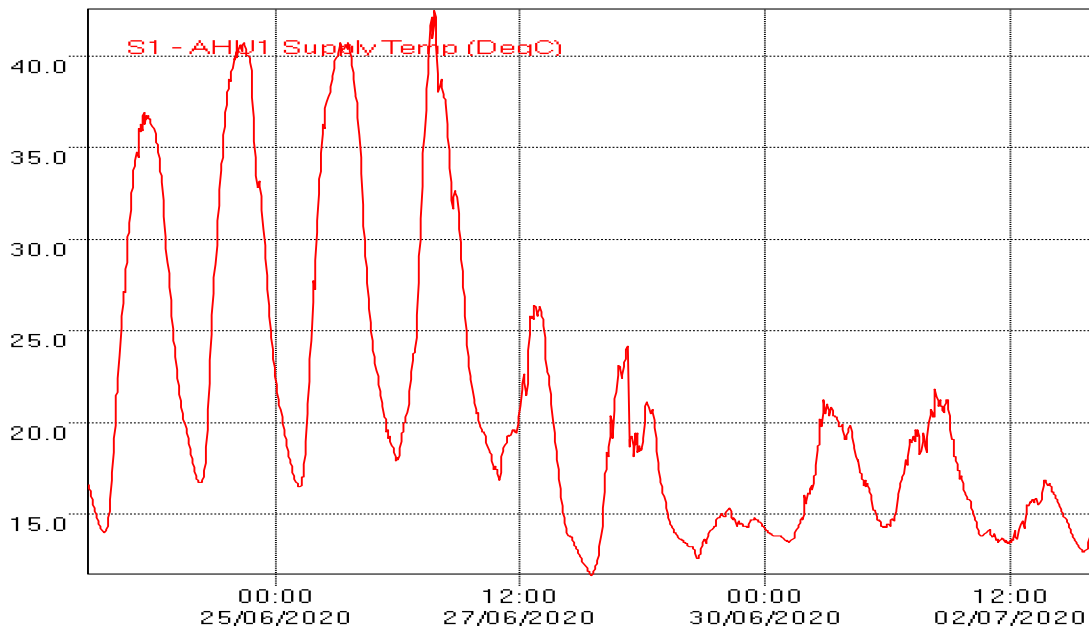
### AHU 1 Supply Air Temperature.

The AHU Temperature control set point is set @ 18°C however as you can see from the graph below, the actual supply air temperature is 14.73°C, that the AHU is not reaching supply air temperature set point, the gas burner demand is currently at 70%. The two off gas fired burners for this AHU are not showing any faults. Unable to access the roof mounted AHU to investigate further.

Looking at the AHU supply air temperatures, and all AHUs were calling for the gas burners to fire I suspect as the weather is warmer, that the gas burners have been switched off at the AHUs to save energy. The current supply air temperatures are neat to the outside air temperature.

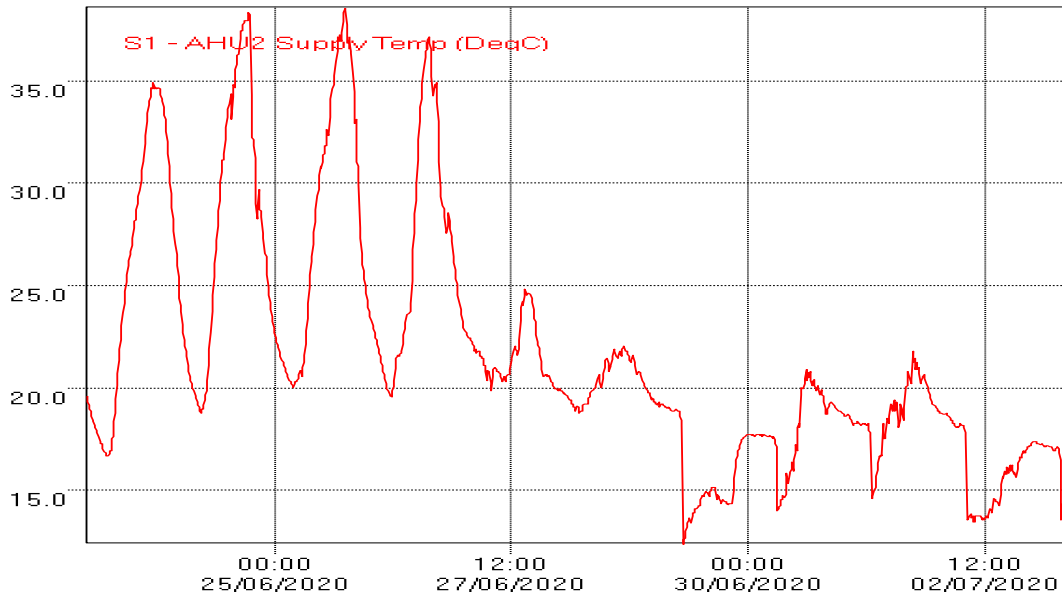
**AHU 2 Supply Air Temperature.**

The AHU Temperature control set point is set @ 18°C however as you can see from the graph below, the actual supply air temperature is 14.64°C, that the AHU is not reaching supply air temperature set point, the gas burner demand is currently at 100%. The two off gas fired burners for this AHU are not showing any faults. Unable to access the roof mounted AHU to investigate further.

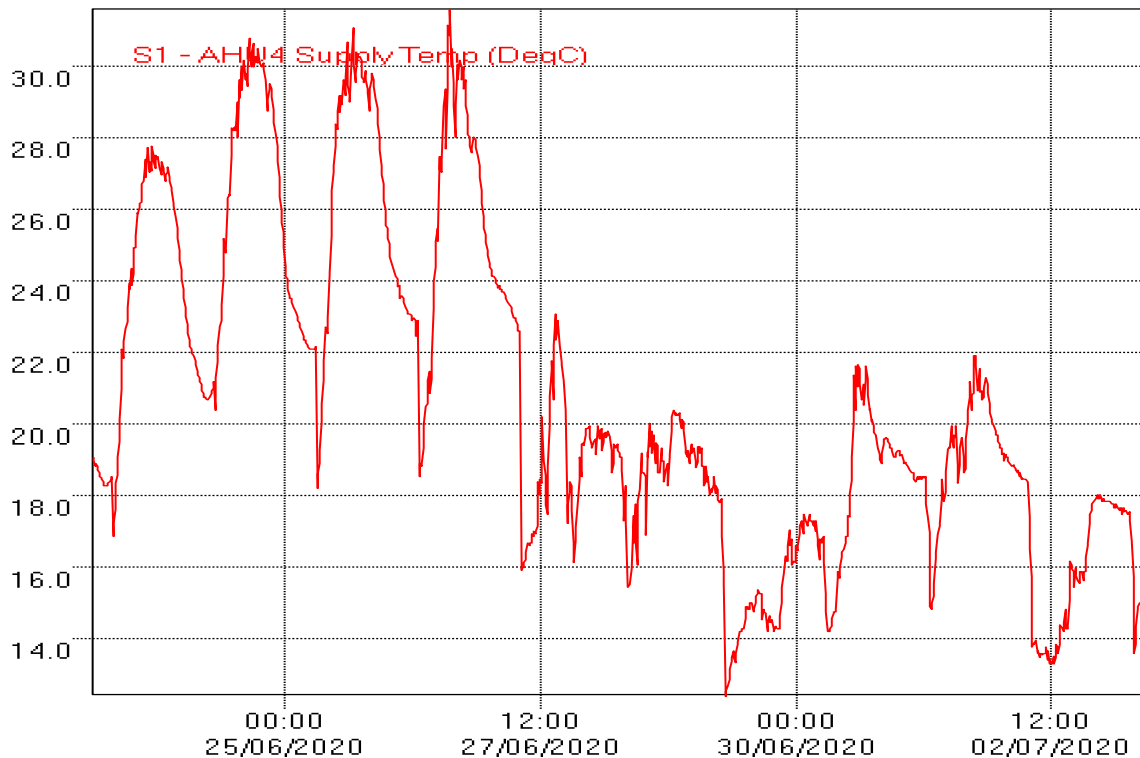
**AHU 4 Supply Air Temperature.**

The AHU Temperature control set point is set @ 18°C however as you can see from the graph below, the actual supply air temperature is 15.16°C, that the AHU is not reaching supply air temperature set point, the gas burner demand is currently at 100%. The two-off gas fired burners for this AHU are not showing any faults. Unable to access the roof mounted AHU to investigate further.

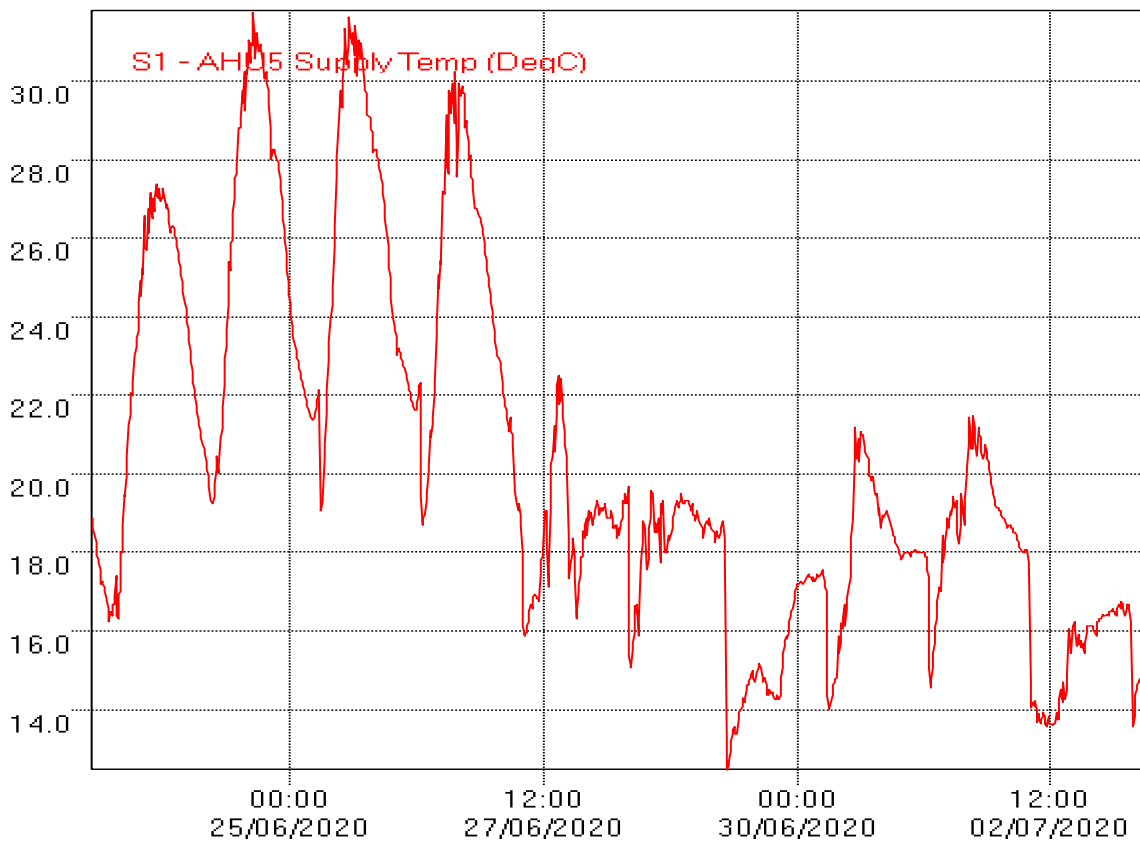
**AHU 5 Supply Air Temperature.**

The AHU Temperature control set point is set @ 18°C however as you can see from the graph below, the actual supply air temperature is 14.99°C, that the AHU is not reaching supply air temperature set point, the gas burner demand is currently at 100%. The two-off gas fired burners for this AHU are not showing any faults. Unable to access the roof mounted AHU to investigate further.

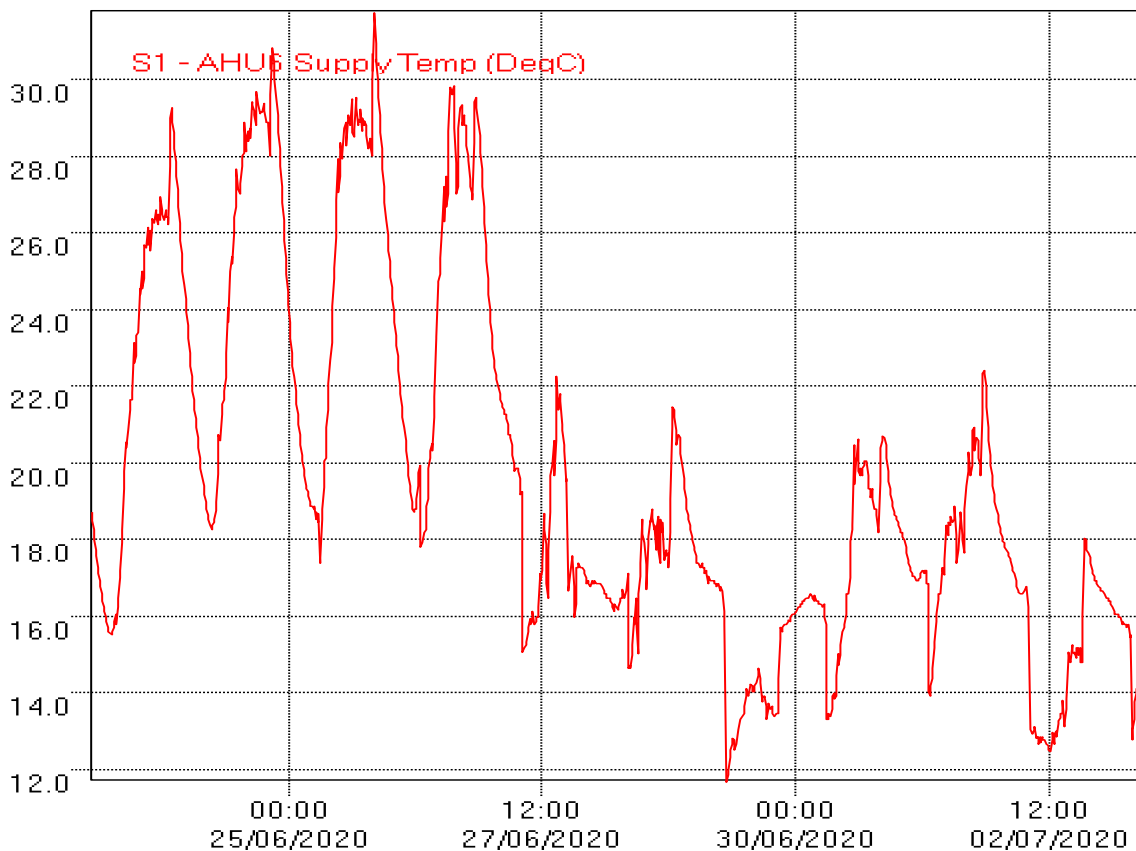
**AHU 6 Supply Air Temperature.**

The AHU Temperature control set point is set @ 18°C however as you can see from the graph below, the actual supply air temperature is 14.47°C, that the AHU is not reaching supply air temperature set point, the gas burner demand is currently at 100%. The two-off gas fired burners for this AHU are not showing any faults. Unable to access the roof mounted AHU to investigate further.

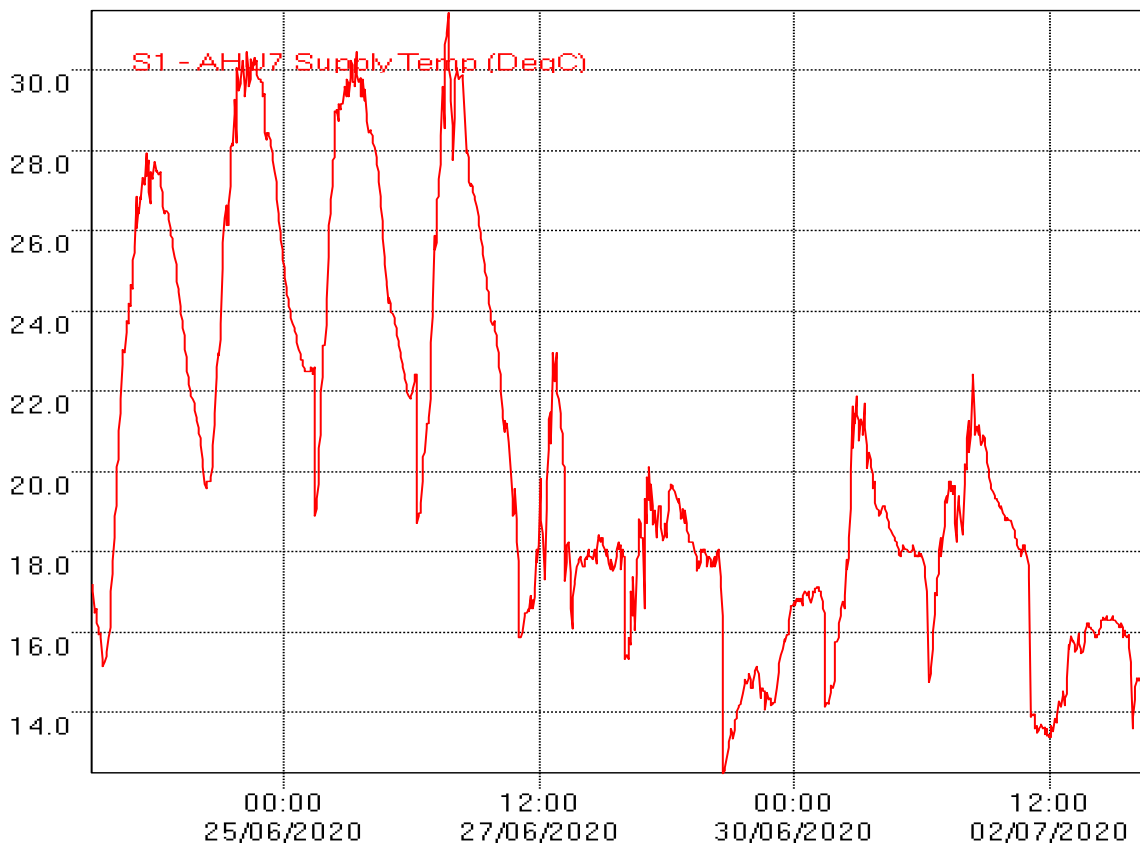
**AHU 7 Supply Air Temperature.**

The AHU Temperature control set point is set @ 18°C however as you can see from the graph below, the actual supply air temperature is 15.26°C, that the AHU is not reaching supply air temperature set point, the gas burner demand is currently at 100%. The two-off gas fired burners for this AHU are not showing any faults. Unable to access the roof mounted AHU to investigate further.
